### Concrete Repair & Restoration

**Project Title: Concrete Wall in Downtown Newport News**

Customer: Hydracrete Services  
Location: Newport News, VA  
Percent Complete: 100%  
Completion: 11/8/09

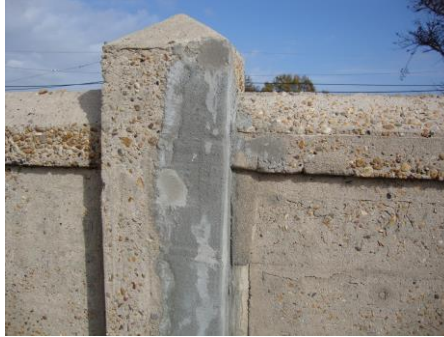
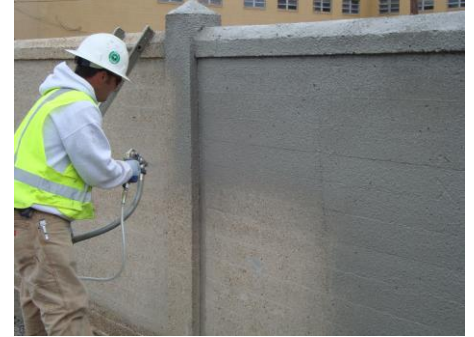
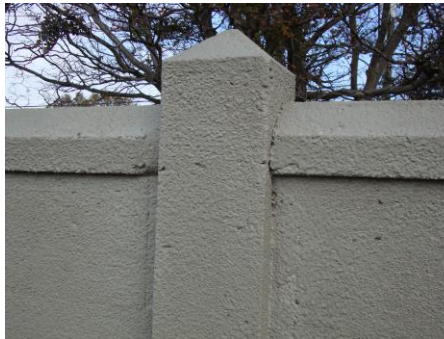
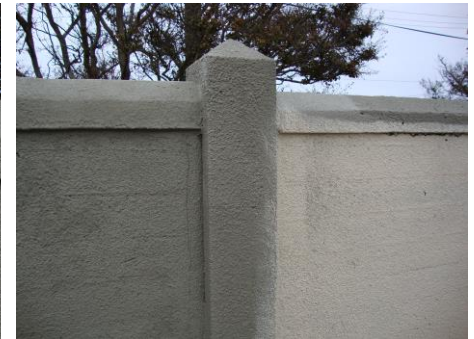
**Scope of Work:** The perimeter concrete wall of a soccer field was in need of repair and restoration. The deteriorated areas were repaired with SikaRepair 223. The entire wall was to be coated with SikaTop Seal 107 as a protective coating. As a decorative coating, the Sikagard 701w was applied as the finished coat.

**Equipment:** The repair materials were mixed with a drill and hand applied. The SikaTop Seal 107 and the Sikagard 701w was applied with a pneumatic sprayer with a hopper.

**Installation:** The process required surface preparation with a pressure washer for the entire wall. The repair material was installed and allowed to cure before placement of any coatings. Each coating was installed to form an aesthetically renewed and durable surface.
